INSPECTION FOR CRACKS ON ENGINE MOUNT

Legacy

SERVICE BULLETIN SB079-1008

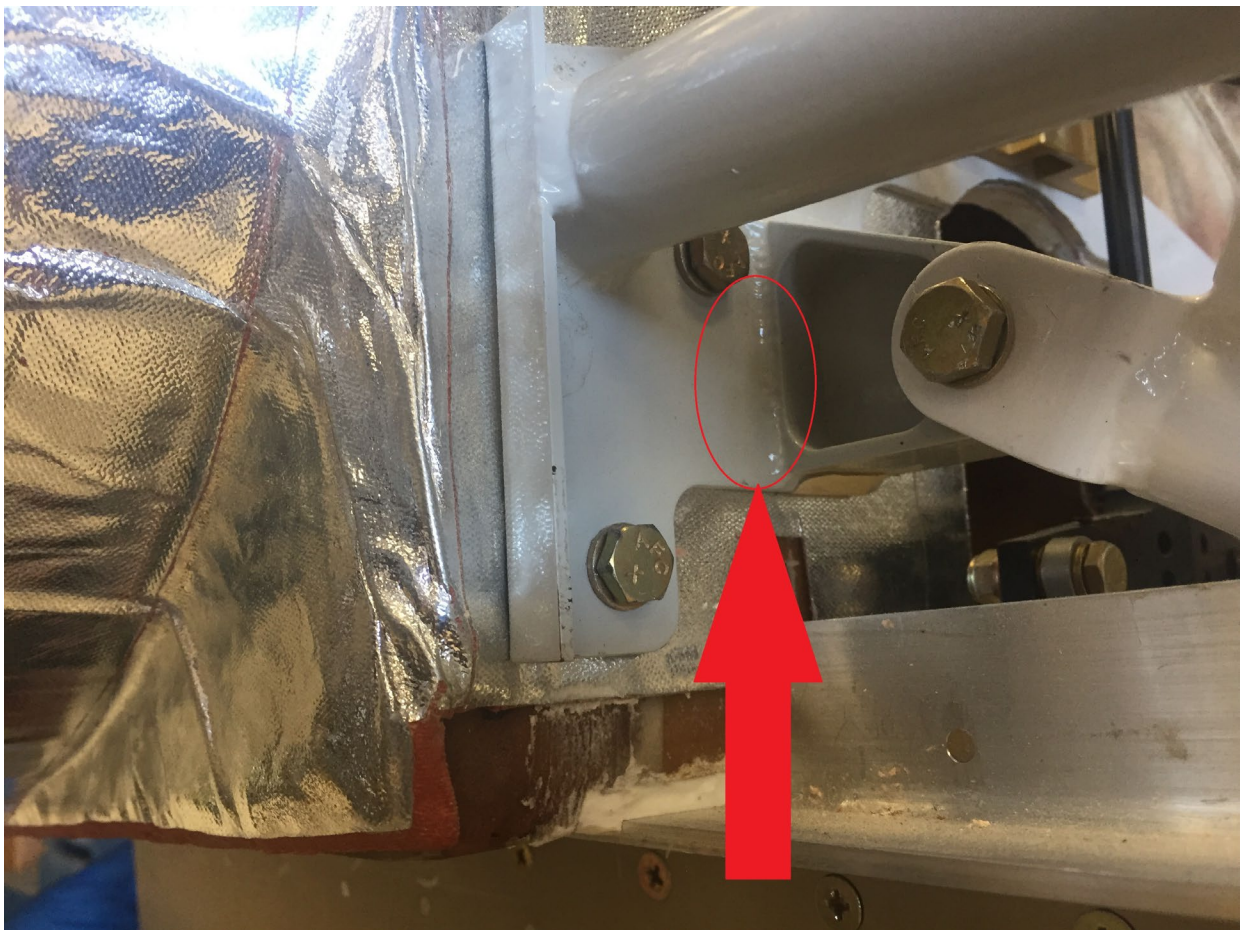
Figure 1
Original Design Lower Drag Links

- 1.1 Inspection for cracks located on engine mount structure at lower RH boss where the nose gear retract cylinder attaches to engine mount.
- 1.2 This Service Bulletin (SB) describes action required by operators of aircraft in the field.

6.1 Obtain access to the lower RH engine mount structure where the nose gear retract and cylinder attaches to the engine mount. Inspect for a crack in the area as noted below in figure 1.

7.1 Lancair is currently working on a redesign/repair that will strengthen the structure in this area. Until then, the engine mount may be removed and the crack welded as necessary locally. Inspect the travel of the nose gear actuating cylinder to determine if the travel is properly set as to not apply unnecessary loads on the engine mount structure during retract and extension of the landing gear.
