SERVICE BULLETIN

SB013-93

Subject: Matco Brake Master Cylinders / Matco MC-3 cylinder shafts

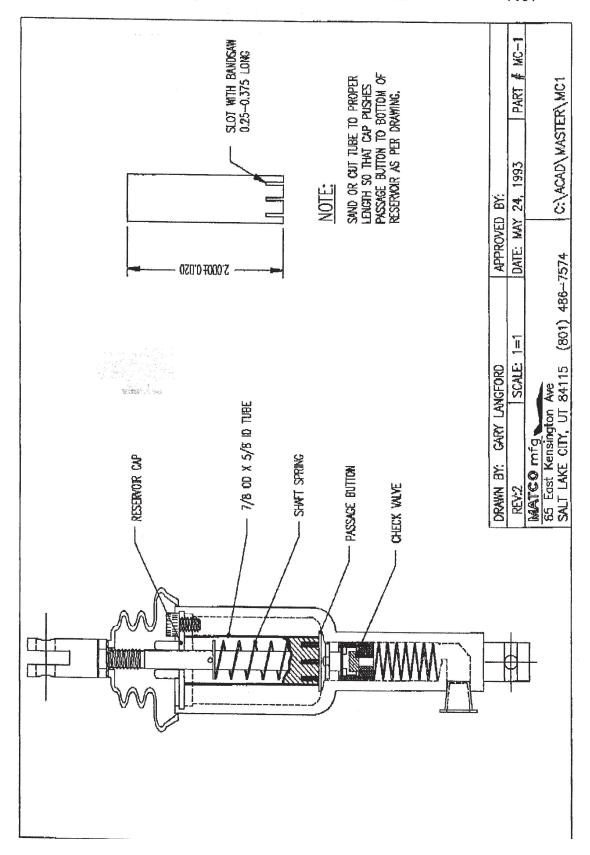
Customer feedback regarding the dual master cylinder braking system has shown that in specific circumstances, the check valve will stay activated after releasing the brake pedal.

This occurs when the pilot activates the master cylinder by pressing the brake pedals, then the copilot activates the slave cylinder. When the pilot releases the brake pedals followed by the copilot, the hydraulic fluid heated by the brakes creates back pressure through the lines. This back pressure is sufficient to overcome the shaft spring which normally opens the check valve. To release this back pressure, the brake bleeder valve must be opened.

Observation in the field has found some MC-3 master cylinders (remote reservoir type) that have leaks around the shaft with some installations. We have noticed that the problem is more chronic with an installation in which a side load is placed on the shaft when activated. For those of you who may experience this problem, you may install a larger O-ring in the sleeve which rides on the shaft. A 6mm x 2mm metric 0-ring has a smaller inside dimension thus sealing the shaft better.

By placing a 7/8" O.D. x 5/8" I.D. tube over the shaft spring, the passage button forces the check valve open when the brake pedal is released. The tube should fit snugly between the passage button and the reservoir cap as shown on the attached drawing. It is recommended that four small slots (.25 - .375 long) be cut in the bottom end of the tube to allow free passage of fluid through the reservoir.

Having performed one of these installations, we determined that the 7/8"O.D. tube can, in some instances based on internal part variations, be too large. The tube must rest on top of the plunger assembly at the bottom of the piston. We used a smaller diameter tube for our modification.

Installation of the new 0-ring should be done in the following manner to avoid cutting the 0-ring when reinstalling the shaft. Remove the small screw in the master cylinder nearest where the shaft enters the master cylinder (part #15 on drawing). Pull on the shaft and the entire shaft, sleeve, and piston will come out. Remove the clevis and lock nut from the unthreaded end of the shaft and slide the sleeve off the shaft past the threads. The 0-ring to be replaced can be seen just inside the sleeve. Replace this 0-ring with a 6mm x 2mm 0-ring. To reinstall the shaft, you should rub the threaded end in paraffin to fill up the thread valleys. Apply vaseline or similar, on the shaft and gently insert the shaft through the sleeve sliding it carefully past the 0-ring. When the lock nut is reinstalled on the shaft, it will clean off the paraffin. Re-assemble by sliding the shaft assembly into master cylinder bore and tightening screw.
