**SERVICE BULLETIN**

**SB022-1094**

Subject: LANCAIR IV,IV-P, Flap Drive Cylinder attach bracket #FM162 -01

Date: 4<sup>th</sup> October, 1994

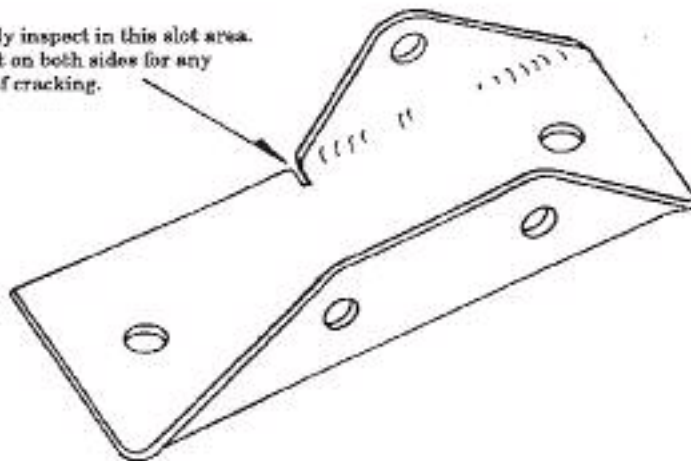
Inspection of our stock has indicated an occasional cracking condition at the indicated area shown below. Therefore an inspection is required and if any signs of cracking are detected, the part should be returned for replacement.

Visually inspect in this slot area. Inspect on both sides for any signs of cracking.

Visually inspect in this slot area.  
Inspect on both sides for any  
signs of cracking.

1. Remove the assembly from the gear box.
2. Inspect both sides of the bracket for any visual signs of cracking around the bend area. Use of a magnifying glass may be of assistance. If a crack has occurred during the bending process, they are readily visible upon close inspection.
3. If acceptable, replace per original instructions .
4. If a crack is detected call our shipping department for a Return Authorization Number, then sent the part back to us for replacement.
