SERVICE BULLETIN

SB030-0597

Subject: Lancair Elevator Travel Stops (IV, ES and MKII)

Ref: Applies to ES, IV, and MKII horizontals and elevators only

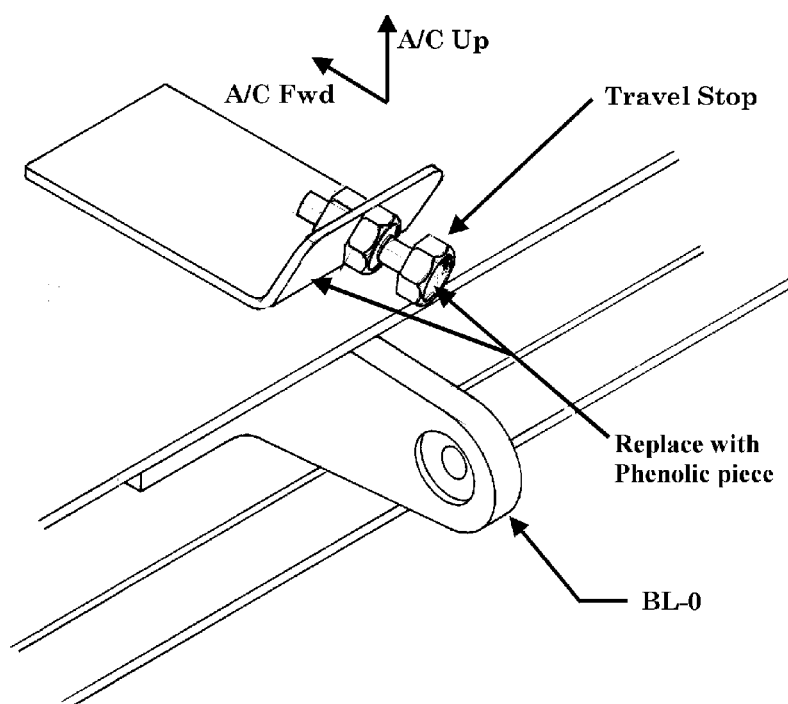
We are recommending all elevators with the travel stop shown in Fig. 1 be inspected for possible control interference. On a recent first-flight inspection, it was discovered that the elevator weldment locked underneath the bolt head during full control deflection as a result of a strong wind gust. This could happen during *full up or down* control deflection. While this is unlikely to occur in flight, all Lancairs with this installation should inspect their travel stops and make the mandatory change.

Typical Travel Stop
