SERVICE BULLETIN

SB036-0697

Subject: Gear Locking Solenoid (Lancair IV & IV -P)

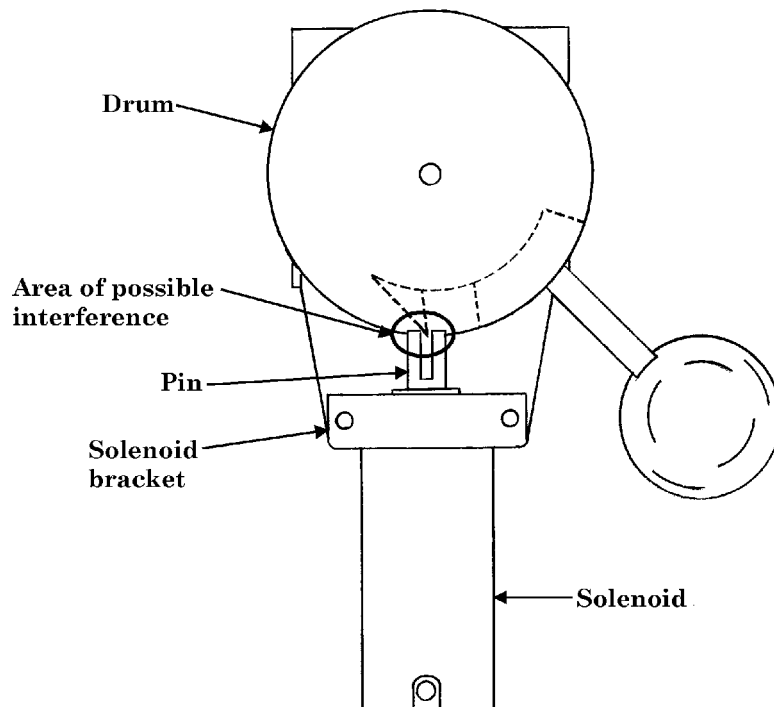
Figure 1
Solenoid detail

Background: The slot in the gear solenoid pin(part number 475 -6-10) in the gear locking solenoid may interfere with drum rotation.

Action: Remove the gear drum. Remove the gear down lock bracket, spring, and washer. Remove the gear solenoid pin and replace it with the new one. Install the circular clip, rubber washer, area washer, and spring on the new pin.

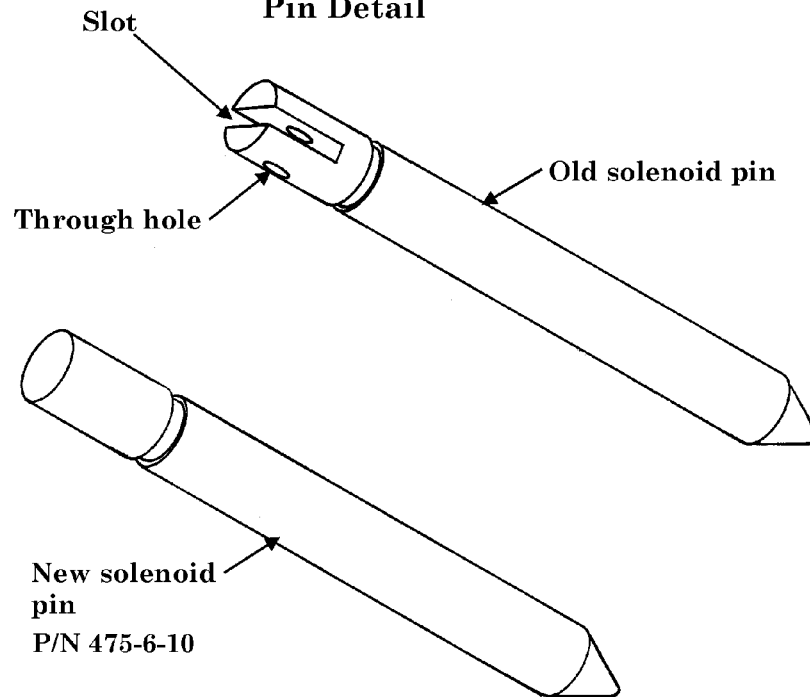
Figure 2
Pin Detail

A new solenoid pin(P/N 475 -6-10) has been manufactured to replace the old pin.
