**SERVICE BULLETIN**

**SB047-0399**

Subject: New LIV Fast-Build Wings, Misplaced Fuel Vent Hole

Status: Mandatory Inspection

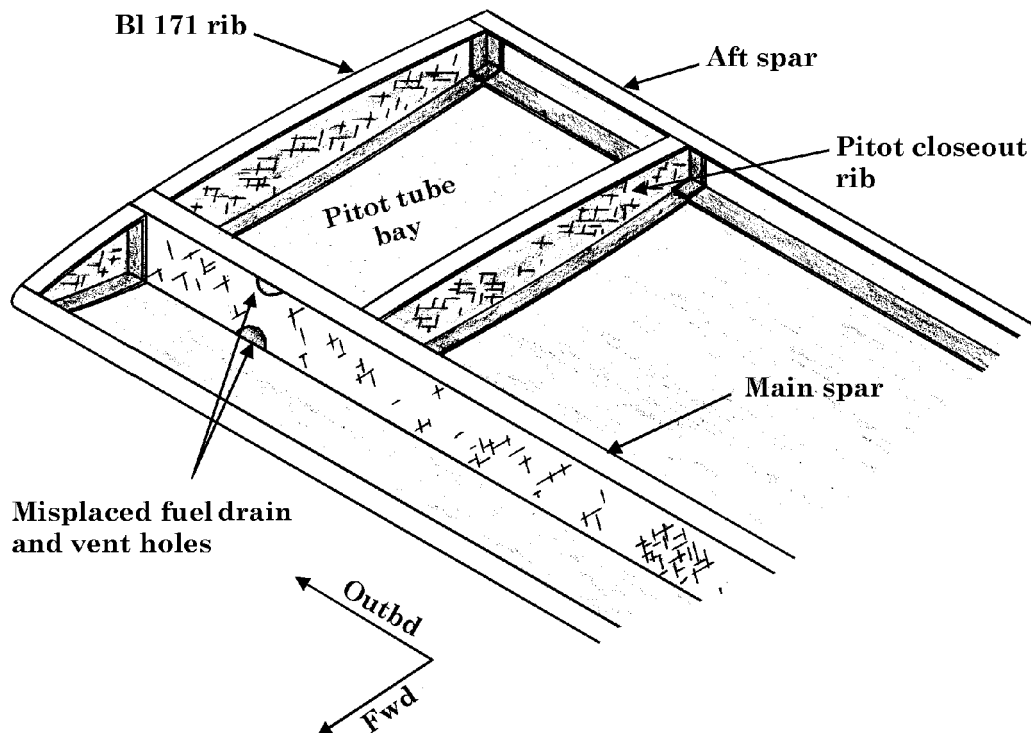
Fig. 1.

**Misplaced Fuel Vent and Drain Holes**

During a quality assurance inspection a misplaced fuel drain and vent hole was discovered (Refer to the above figure). The vent and drain hole lead right into the pitot tube compartment inboard of the BL 171 rib.

Action: Verify that there are no vent or drain holes leading into the pitot tube compartment from the fuel tank. If there are misplaced vent or drain holes, they must be sealed. This is an easy task if the wing is open (refer to the figure below).

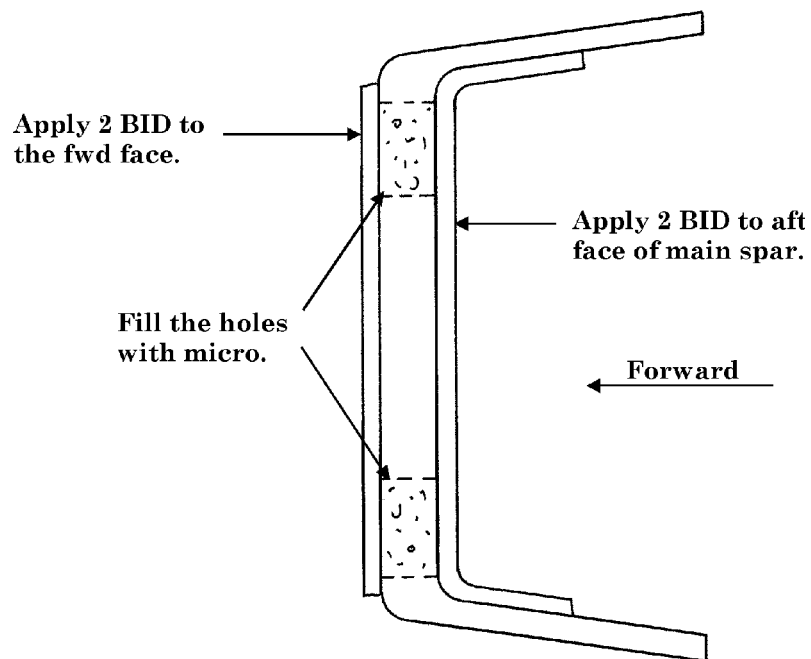
Fig. 2.

### Sealing Fuel Vent and Drain Holes

If the wing is closed, the BID must be installed through the BL 171 rib aft of the spar. In this case it is acceptable to apply 4 BID just to the aft side of the spar and none to the front.
