SERVICE BULLETIN

SB055-0600

Subject: Lancair IV/IV-P, ES and 360 Nose Gear Struts

Date: 21st June, 2000

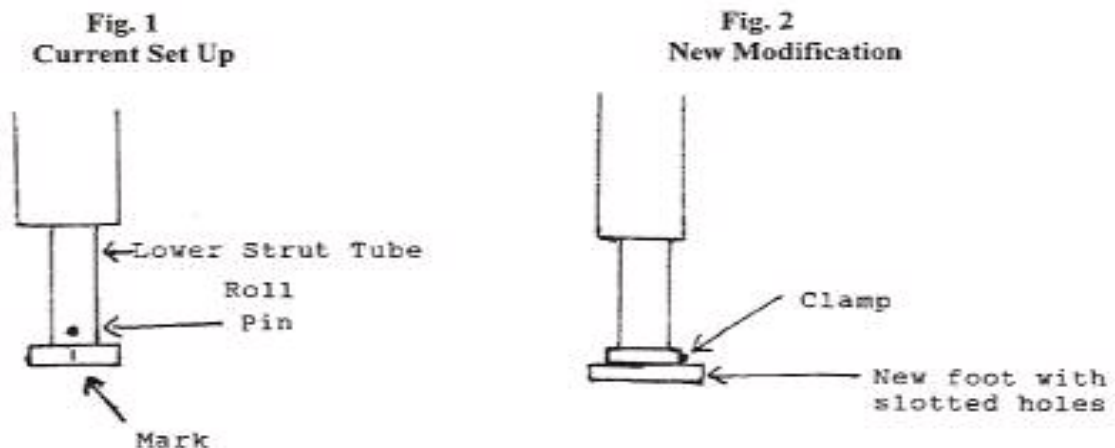
Nose Gear Strut

The shear pin that secures the foot onto the strut has a possibility of getting loose. If this occurs, it can result in shearing of the roll pin. This can then allow the nose gear fork to rotate on the lower strut tube. In the IV/IV-P and 360 this can cause binding in the wheel well area, and in the ES this can allow the wheel to swivel in flight.

Action #1 – Inspection to verify alignment: Raise nose gear off of the ground to check for a tight strut/foot alignment. Once this is verified, make a permanent mark on the foot under the roll pin. Inspect the roll pin & mark for alignment on each pre-flight.

Action #2 – Upgrade Model: All new struts have a clamp holding the foot onto the strut instead of the roll pin. This requires a new foot with slotted holes and the clamp. This modification must be performed at Lancair in Redmond OR, or at Esco in Australia. Parts cost is estimated at \$150, plus one hour of labor (\$50).
