SERVICE BULLETIN

SB059-0801

Subject: Legacy Rudder Trim Tab Reinforcement
Date: 23rd of August, 2001
Ref: Construction Manual, Attached pages
Pages: 1 (2 sides)
Status: Mandatory Compliance

Legacy Rudder Trim Tab Reinforcement

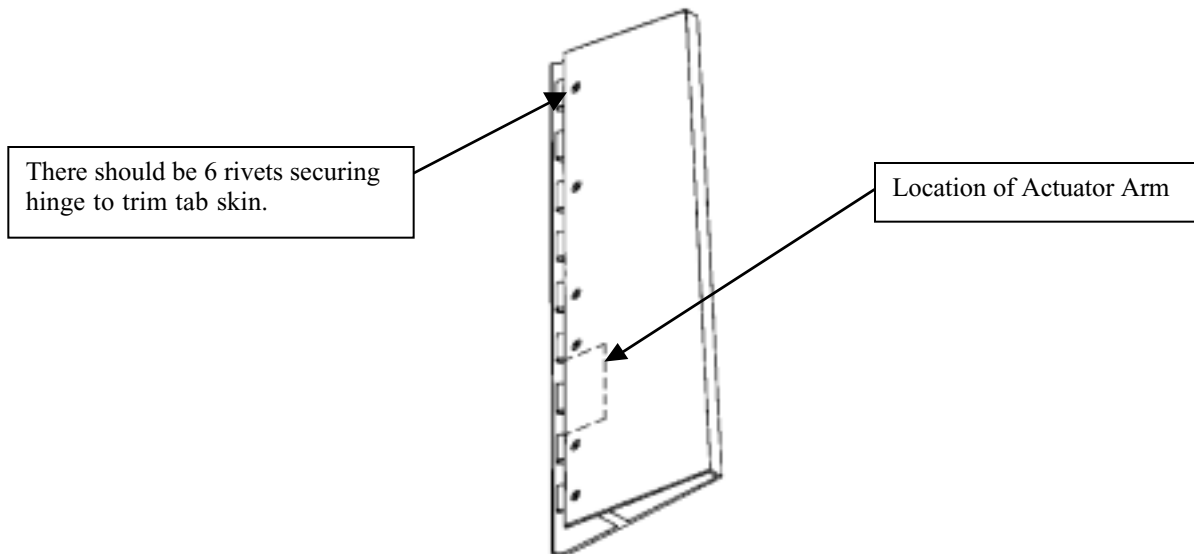
Fig.1

The Legacy rudder trim tab secures to a hinge with structural pop rivets (refer to figures below). Legacy kits with serial numbers 104 through 138 are lacking two of these rivets. There should be a total of 6 rivets securing the trim tab

Inspect your rudder trim tab and count the number of rivets securing the skin to the hinge. If there are only a total of 4 rivets (not counting the two rivets securing the actuator arm to the hinge) you must comply with the service bulletin.
