SERVICE BULLETIN

SB067-0803

Subject: Lancair IVP, IV, ES, 320, 360, and Legacy Nose Gear Strut Clamp

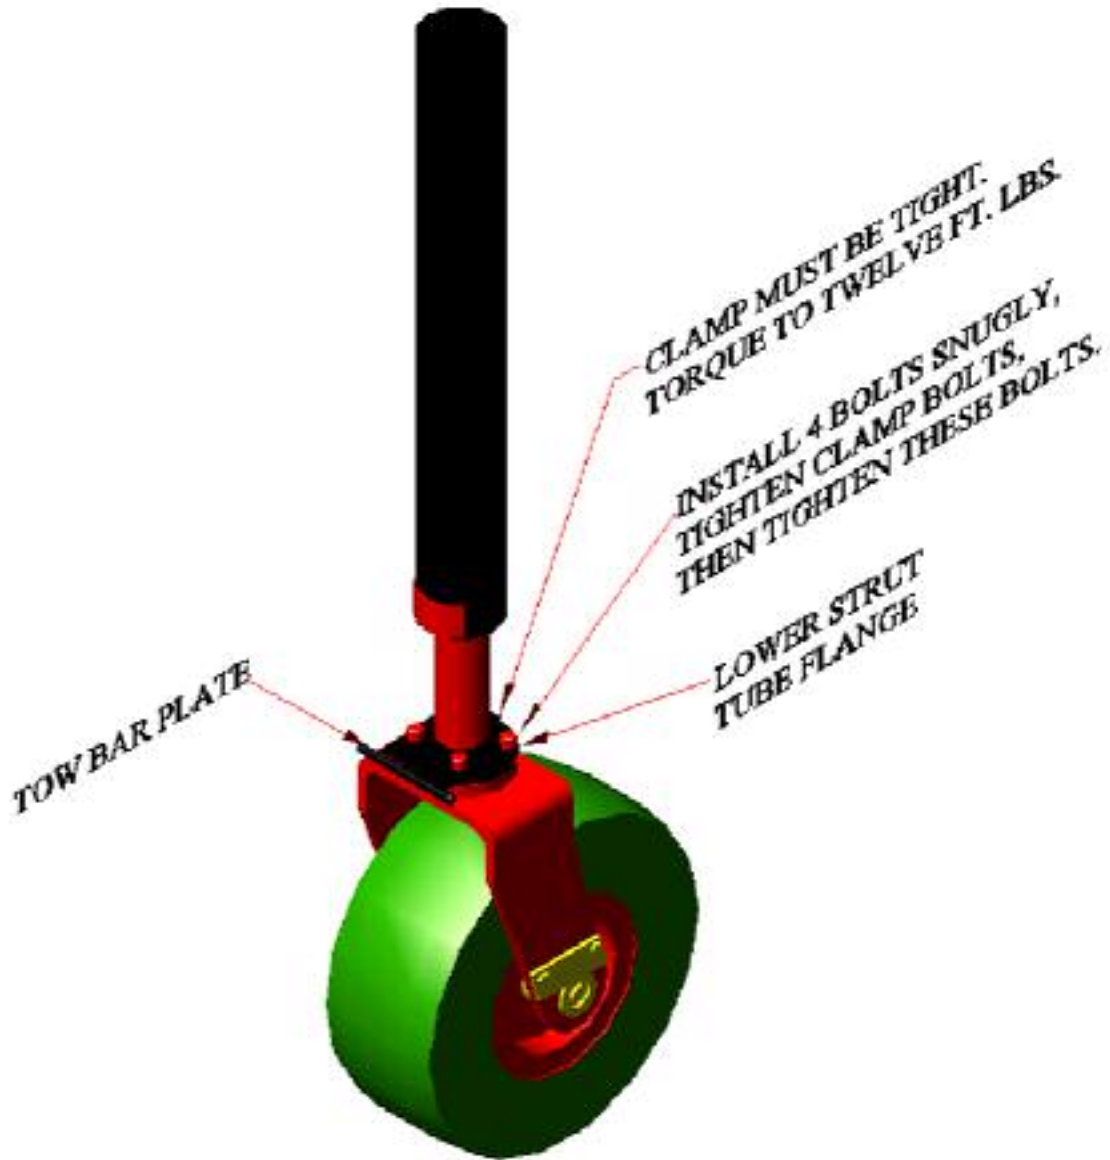
Figure 1
Applies to Lancair IVP, IV, ES, 320, 360, and Legacy

As discussed in SB055 and SB060, it is important to lock the flange to the lower strut tube. The original lock collar has an approximately 1" weldment connecting the flange to the clamp. This weldment has a tendency to crack and sometimes break.

Remove the tow bar bracket (if necessary). Closely inspect the weldment on the lock collar. Cracks usually occur on the edges and are most noticeable on the underside of the clamp.

An upgraded, machined, two-piece clamp (Part Number Z02E1014) is available to fix this problem. There are two ways to install the new clamp. If removal of the entire nose strut is not necessary, (for example, if the strut has just been resealed, or is not leaking or bleeding down) you can cut the old clamp off. Be very careful not cut into the flange. If the nose gear is suspected of leaking, it is recommended that the nose gear (with the wheel, axel, fork and connecting blocks removed for lighter shipping weight) be shipped to Lancair for resealing. The new lock clamp will be installed at this time.

Proper installation of the new clamp is important for peak performance. Loosely install the clamp on the lower strut tube, resting on top of the flange. Install the four bolts for the fork just snugly to allow proper seating of the clamp to the top flange face. Torque the two allen side bolts on the clamp to 12 Ft/Lbs in steps. Reinstall the remaining nose gear components.
